Manhole Inspection Summary

Manhole # S43II_030MH

Insp Date: **4/24/08 8:13 AM**

Location Address: **Oliver St**

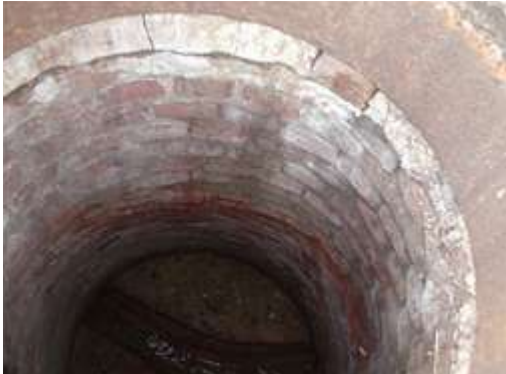
Defect 2

Condition: ☐ Sound ☐ Cracked ☐ Root Intrusion ☒ **Loose Brick** ☒ **Deteriorated**

Loose Bricks

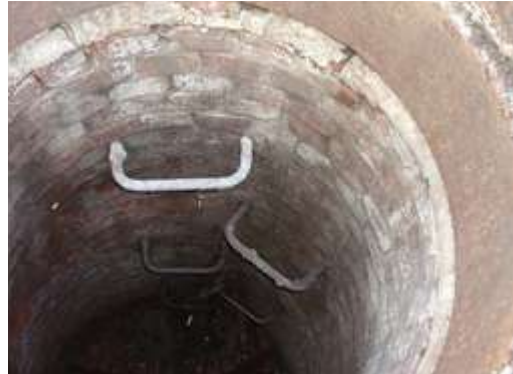
Defect 1

Infiltration: ☐ None ☒ **Joint** ☐ Cracks ☒ **Mortar** ☐ Roots ☐ Wall

Deterioration

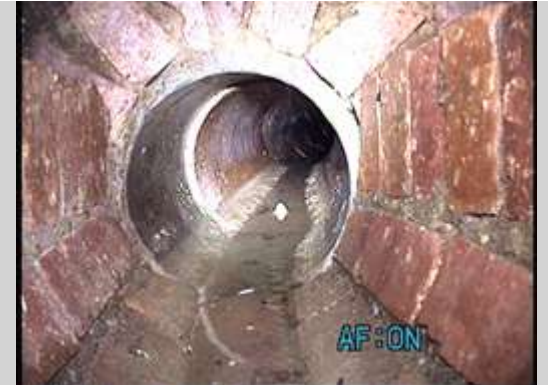
12 O'Clock Outflow

8 in. Circular Gravity Sewer
Pipe Out @ 12 O'Clock

Pipe Height: **8.4** (in.) Rod and Bar (Angled)
Pipe Material: **Clay** ☐ Pipe Lined
Invert Depth: **10.10** (ft.) Flow Characteristics: **Fast**
Deposits: ☒ None ☐ Mud ☐ Sludge ☐ Debris ☐ Grease
Silt Depth: (in.) Deposits Extent:
Infiltration: **None** Pipe Seal Cond: **Sound**

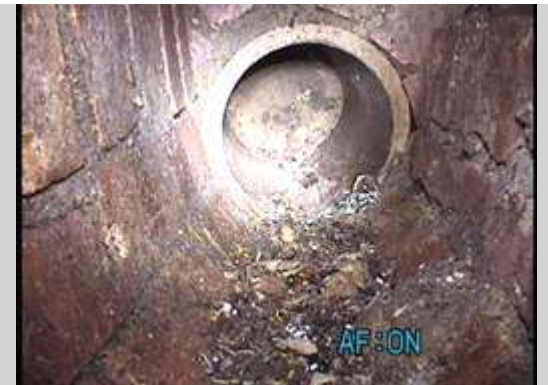
5 O'Clock Inflow

6 in. Circular Gravity Sewer
Pipe In @ 5 O'Clock

Pipe Height: **6** (in.) Rod and Bar (Angled)
Pipe Material: **Clay** ☐ Pipe Lined
Invert Depth: **9.50** (ft.) Flow Characteristics: **None**
Deposits: ☒ None ☐ Mud ☐ Sludge ☐ Debris ☐ Grease
Silt Depth: (in.) Deposits Extent:
Infiltration: **None** Pipe Seal Cond: **Sound**

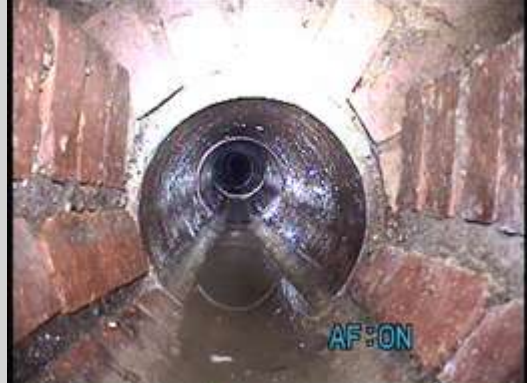
7 O'Clock Inflow

8 in. Circular Gravity Sewer

Pipe In @ 7 O'Clock

Infiltration: **None** Pipe Seal Cond: **Sound**
